**DEPARTMENT OF TRANSPORTATION**

Contract #: 04-0120F4Cty: SF/ALA Rte: 80 PM: 13.2/13.9File #: 69.28**WELDING INSPECTION REPORT****Resident Engineer:** Siegenthaler, Peter**Address:** 333 Burma Road**City:** Oakland, CA 94607**Report No:** WIR-018787**Date Inspected:** 01-Dec-2010**Project Name:** SAS Superstructure**OSM Arrival Time:** 1900**Prime Contractor:** American Bridge/Fluor Enterprises, a JV**OSM Departure Time:** 700**Contractor:** Zhenhua Port Machinery Company, Ltd (ZPMC), Changxing Island **Location:** Shanghai, China**CWI Name:** See Below**CWI Present:** Yes No**Inspected CWI report:** Yes No N/A**Rod Oven in Use:** Yes No N/A**Electrode to specification:** Yes No N/A**Weld Procedures Followed:** Yes No N/A**Qualified Welders:** Yes No N/A**Verified Joint Fit-up:** Yes No N/A**Approved Drawings:** Yes No N/A**Approved WPS:** Yes No N/A**Delayed / Cancelled:** Yes No N/A**Bridge No:** 34-0006**Component:** OBG**Summary of Items Observed:**

On this date CALTRANS OSM Quality Assurance (QA) Inspector, Mr. Paul Dawson, arrived on site at the Zhenhua Port Machinery Company (ZPMC) facility at Changxing Island, in Shanghai China, for the purpose of monitoring welding and

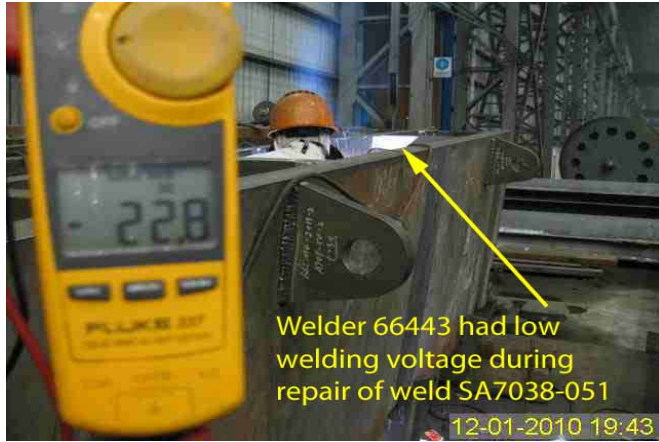
repair of this weld. Mr. Bao Qian informed this QA Inspector that the depth of the weld repair gouge prior to welding was 35mm. This QA Inspector measured a welding current of approximately 240 amps and 22.8 volts. This QA Inspector observed that the minimum welding voltage in the WPS is 23.9 volts and that Mr. Hu Feng Jian has a welding voltage that was approximately 1.0 volt below this minimum limit. This QA Inspector showed ABF CWI Mr. Bao Qian of the welding voltage meter and he agreed the welding voltage was below the minimum and he adjusted the welding voltage to approximately 26 volts. This QA Inspector observed Mr. Niu Yuehai appeared to be certified to make this weld and the base materials were heated with electric heaters to preheat the base material temperature of this weld joint. Following adjustment of the welding voltage, items observed on this date appeared to generally comply with applicable contract documents. See the photograph below for additional information.

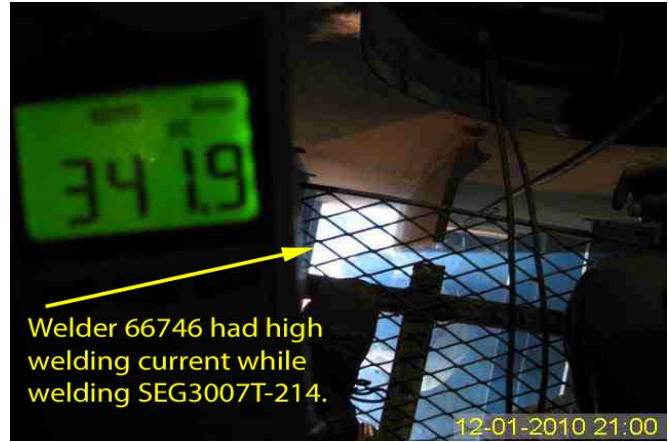
This QA Inspector observed ZPMC welder Mr. Wang Quanlin stencil 066746 used flux cored welding procedure specification WPS-B-T-2231-ESAB to make OBG segment 13AE weld SEG3007T-214. This QA Inspector observed a welding current of approximately 342 amps, 33.0 volts and Mr. Wang Quanlin appeared to be certified to make this weld. This QA Inspector observed that the WPS lists a maximum welding current of 320 amps and maximum of 26.6 volts and that Mr. Wang Quanlin has high welding current and voltage. This QA Inspector showed ABF CWI Mr. Bao Qian and QC Inspector Mr. Zhong Hai the welding meter and they agreed the welding current and voltage were both above the maximum limits. QC Inspector Mr. Zhong Hai adjusted the welding machine controls to have a current to approximately 300 amps and the 25 volts. Following adjustment of the welding machine, items observed on this date appeared to generally comply with applicable contract documents. See the photograph below for additional information.
